ACCIDENT/INCIDENT ALERT

No. 10, February 2006

Safety check for Indalex Werner fibreglass extension stepladder

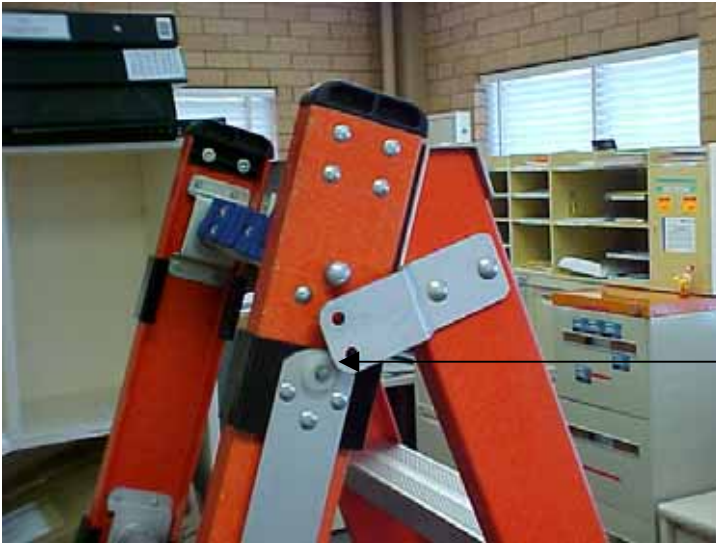
Both of the rivets that form the hinge on each side of the ladder had broken and the large rivet top was missing. On the left side, the rivet had completely detached from the locating hole and on the right side the head had sheered off but was still fixed in the locating hole. [See photos over page.]

Head sheared off left-hand hinge rivet.

- All owners or users of the Indalex Werner fibreglass extension stepladder 1.8-3.0 m are to physically inspect the ladder to check for wear in the hinge plates and riveted joints.
- If any rivets are broken, or the joint is 'loose or sloppy', the ladder should be replaced.
- Each time a ladder is used, it must be inspected for any signs of damage, splitting or major defects.

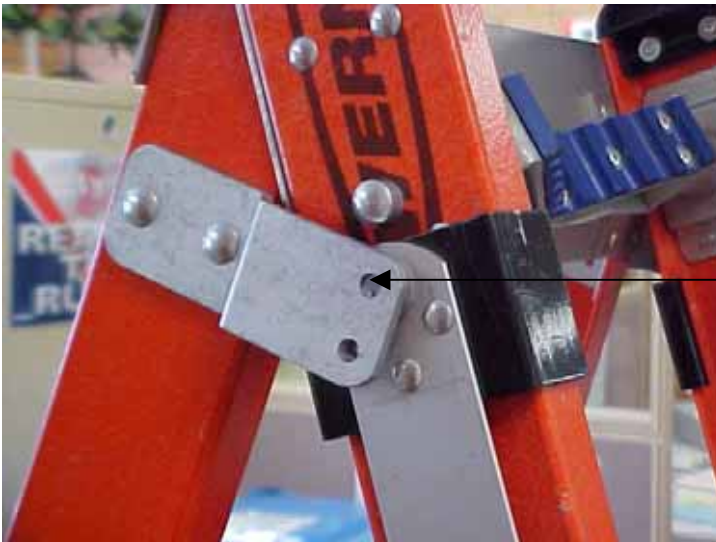
Right-hand hinge rivet with head sheared off still located in metal hinge - functioning as usual.

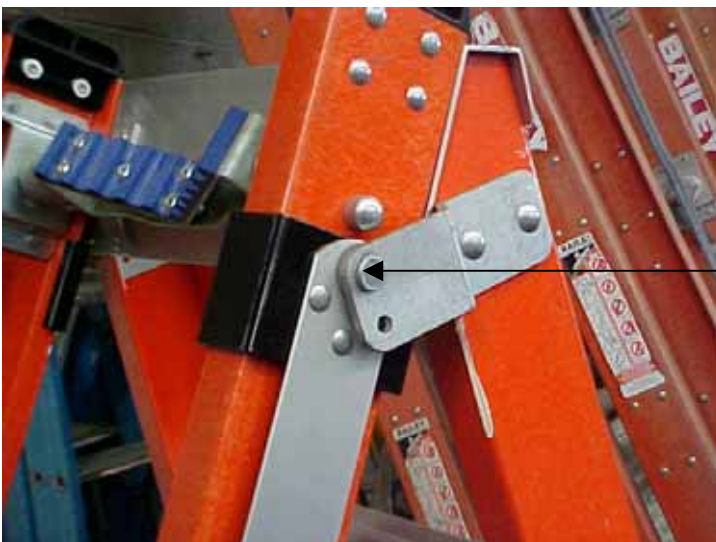
Normal hinge rivet arrangement.
