Near-Miss Incident — Axle Stand Fails Under Load

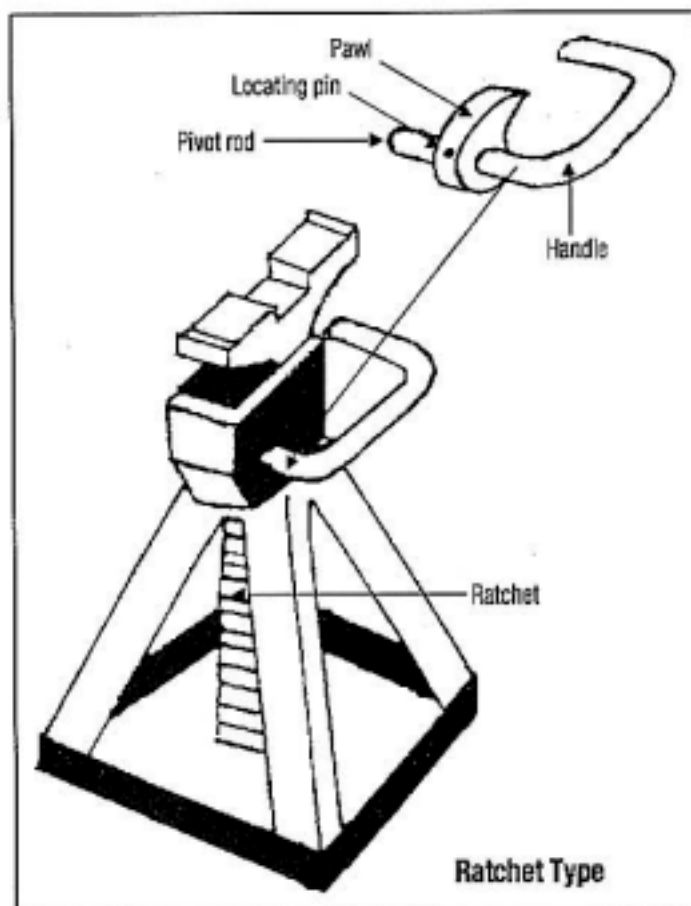
The incident happened while the stand was being relocated under a partially-lifted load by holding and pulling the handle which was connected to the pawl. The locating pin, fitted between the pawl and its pivot rod with the handle, failed. The pawl was not able to be engaged with the ratchet because of the failure of the locating pin and, at the same time, the load came down.

An OSH engineer examined the failed axle stand and discovered that the locating pin was hammered through a hole in the pawl and then through a hole in the pivot rod with the handle, to lock the pawl onto the rod. It appeared that the locating pin with a diameter of about 3 mm, was made of mild steel. The pin was easily broken by applying a force on the handle by hand.

The hazard is that the pawl will not engage properly if the locating pin fails, and there will be no force on the handle to pull the pawl down to engage with the ratchet.

1. Advise their principal or the manufacturer of the axle stands of the incident and to replace the locating pin with a higher strength material so that it is not broken by applying a force on it with hands on the handle during usage.
2. Notify their agents of the potential danger with the failure of the pin and advise all clients who own one of these stands to replace the locating pin with a higher strength material.
3. Clause 4.1 of the New Zealand Standard NZS/AS2538: 1985 *Vehicle support stands* requires that materials used in the manufacture of the support stand shall not have been subject to stress and strains which would result in failure and shall be

4. Check their other models of equipment including the 3-tonne axle stands to ensure that they are safe and comply with the New Zealand standard.
