# Accident Involving a COMPAC Fruit Grading Machine

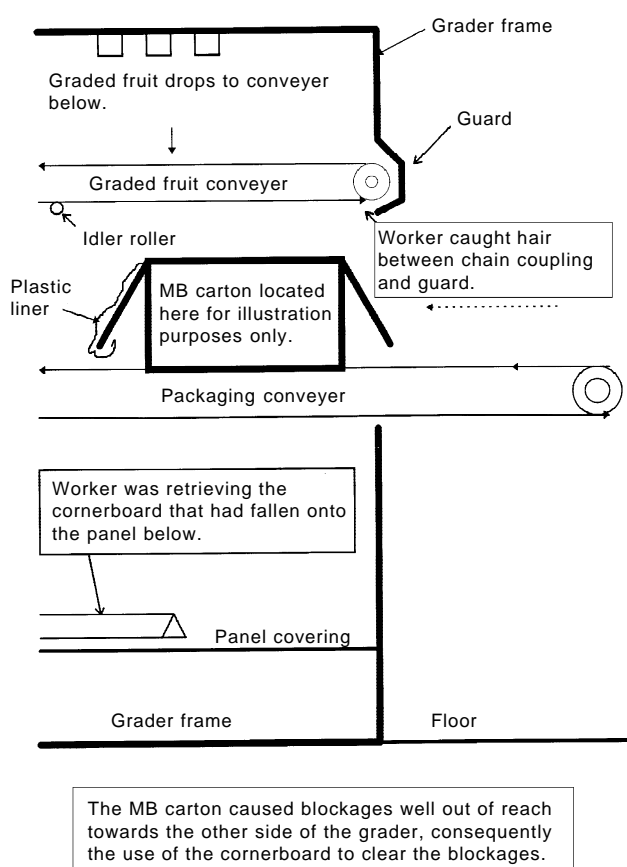
A rotating shaft drives the graded fruit belt conveyors to the packing side of the grader. The shaft is covered by a U-shaped metal panel preventing direct contact to the shaft and chain couplings. Because of the panel covering the shaft, its presence is not an obvious hazard.

With her head past the panel, the open side exposed her bunched hair to the rotating shaft and coupling. Her hair caught in the nip area created between the guard and a chain coupling. Fortunately, no meshing of chain and sprockets existed, otherwise scalping may have occurred.

COMPAC Grader (side view)

1. System of addressing blockages occurring on the packaging conveyor; and
2. Guarding standards on these machines and where appropriate:
  - Provide additional guarding to panel guards driving the graded fruit belt conveyors.
  - Install an emergency stop mechanism on the packaging side of the grader.
  - Seek assistance from the manufacturer/agent to remedy the problem of packaging causing blockages on the conveyor.
