## Breach Rail Safety Switches on Rotary Milking Sheds

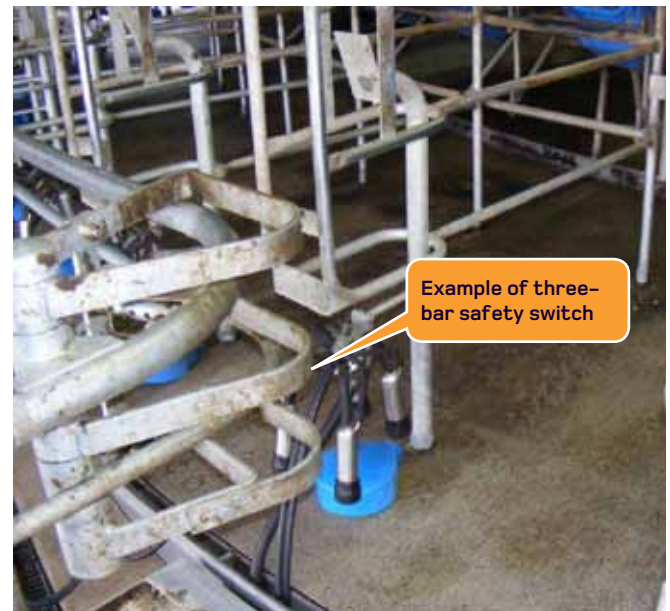
By February 2007, Delaval had developed a newer model the "Parallel Rotary" (PR) that replaced the "Omega". Due to a new design feature on the bottom of the bail called a "pull point", a second bar was required at the bottom of the breach rail safety switch. As a result of the second bar being added, a number of incidents involving injuries to cows were reported. These injuries occurred because the cows' heads went between the two bars and the safety switch was not activated.

currently being used on the PR platforms was fitted, and this appears to be a satisfactory solution to prevent a reoccurrence of this accident. This would also be the case on other Omega platforms or platforms carrying switches of similar design.

Rotary cow shed owners should check the breach rail safety switch fitted to their platform, and ensure that it conforms to the three activation bar configuration pictured below.

It is the Department's advice that breach rail safety switches on rotary milking sheds be checked to ensure that activating bars on these switches conform with the configuration pictured above.
