KING HITTER POST DRIVER – approximately 20 years old

INCIDENT

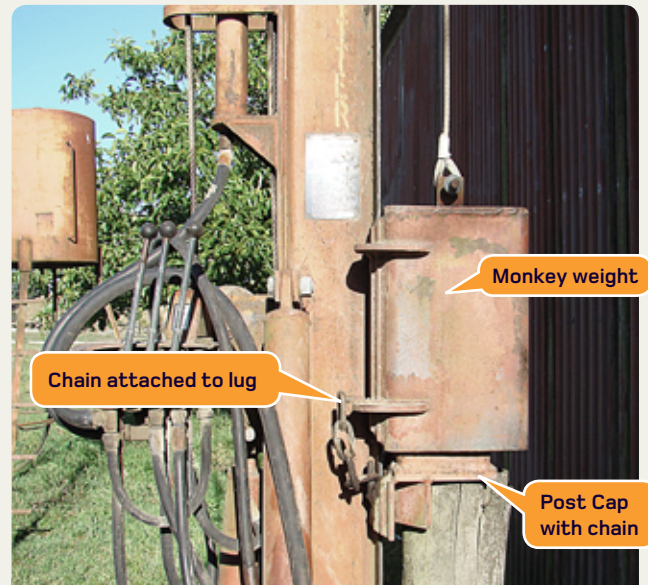
1

Example of an older model King Hitter Post Driver, similar to the one involved in this case.

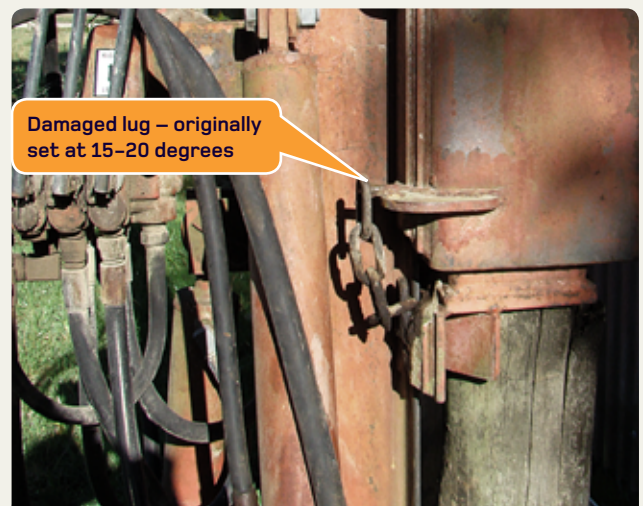
2

- The Post Cap weighs 15kgs
- The machine is approximately 23 years old.
- The 12mm welded lug was worn almost parallel providing no adequate means to retain the chain.
- A combination of tractor/machine vibration and an insecure connection point is the most probable cause of the Post Cap being dislodged.
- The manufacturer advises that later machines do not have a welded lug on the weight, the design having been modified.
- It is unknown when the manufacturer changed the design because company records were destroyed in a fire.

Detail of the welded lug which requires the chain to be placed on the cap.

- Inspect the lug for wear and tear and modify this contact point to ensure the Post Cap chain is secured.
- Enter this hazard and any similar ones into your hazard register along with your means of hazard control.
