# ACCIDENT ALERT

## MIG Welding Explosion: Aluminium Boat

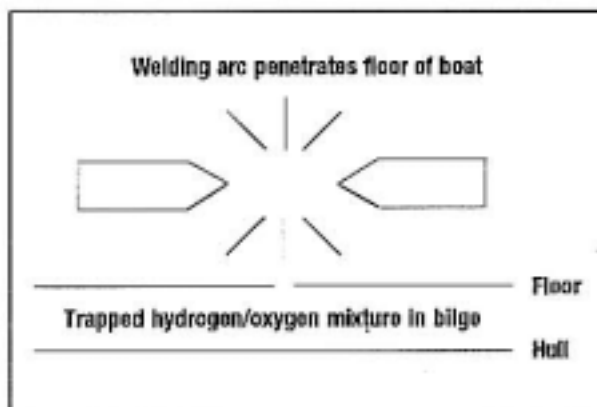
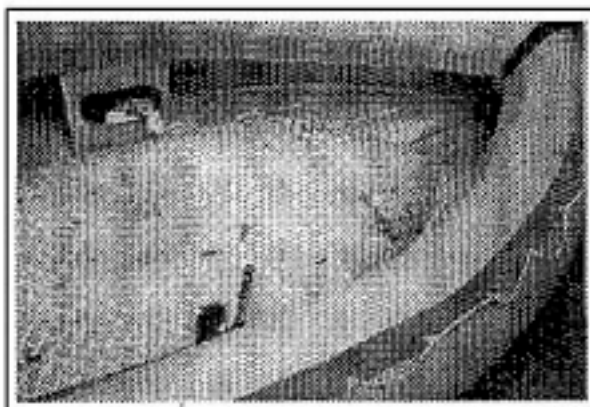
A man was attempting to MIG weld an aluminium lug plate onto the floor pan (also aluminium) of a Naiad aluminium inflatable dinghy (N.43029). He tacked the plate into position and started to weld it. It was not penetrating through to the hull. He increased the welder temperature and began welding a second time. An explosion occurred throwing him 3-4 metres away.

It was not possible to substantiate the exact cause. The most likely cause was the ignition (by the MIG welding torch) of a highly combustible hydrogen/oxygen gas mixture trapped in the pressure tight bilge of the boat.

The hydrogen may have been generated by:

1. A reaction between aluminium corrosion and moisture in the bilge compartment;

2. Decomposition of water in the high energy welding arc; or
3. Release of hydrogen trapped in the gas pores of welds attaching the floor to the hull.

- A number of incidents of a similar nature have occurred in the past and greater awareness of the hazard is needed.
- Manufacturers should attach a warning plate or stamp on their boats.
- The boat design should allow for a through flow of ventilation (for example, by having extra bungs) so the boat can be ventilated prior to welding.
- The work should be thoroughly ventilated before and during the welding process.
- Because of the complexity of the problem and different designs of boats, emphasis should be placed on alternatives to welding, such as the use of screws and rivets, etc.
