ACCIDENT/INCIDENT ALERT

19 June 2002

Fatality While Unloading a Semi-Curtainsider

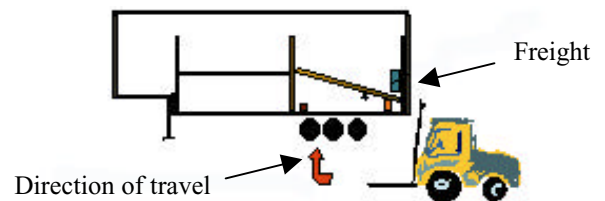
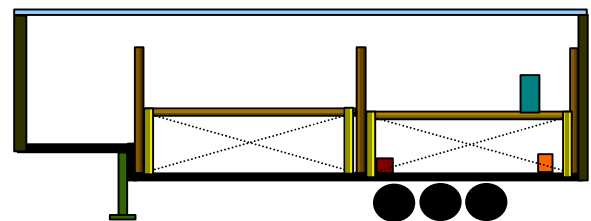
The mezzanine floors are attached to each trestle using platform support brackets. Two support brackets are welded onto each end of the mezzanine floor. Each floor weighs approximately 1200 kg and is adjusted by a

The investigation revealed that the floor fell because it was not secured on the hooks of the rear trestle, but was either balancing on the 25 mm lip of each hook or on the top of each hook itself.

1. Change mountings on the mezzanine floor to be more positive.
2. In addition to the LTSA requirements, secure the mezzanine floors to the lower floor by certified strops.
3. Develop systems to ensure loads are inspected, and any hazards identified, before the unloading commences.
4. Ensure workers are not under the mezzanine floors when either a forklift or other workers are carrying out tasks.
5. Check that the mezzanine floors are securely attached and haven't been dislodged during transit.
6. Develop procedures for forklift drivers and employees unloading these line-haul units.
