# Safety Lines

ENGINEERING SAFETY NEWSLETTER, OCCUPATIONAL SAFETY AND HEALTH SERVICE

No. 51, September 2001

## Rock Solid?

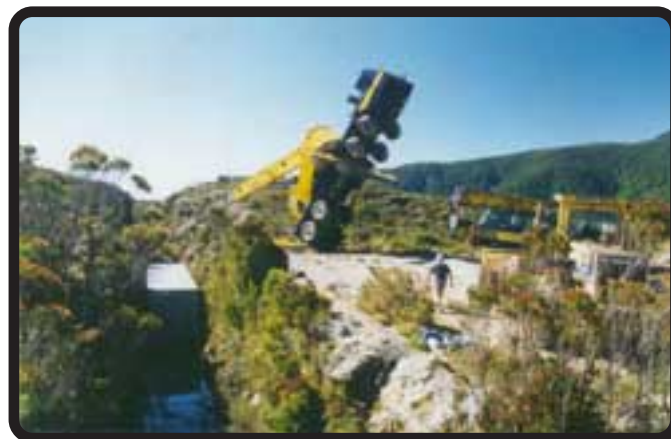
Recently an accident occurred which serves as a reminder that the rock beneath your feet (or crane) is not always as solid as it seems. A 60-tonne mobile crane overbalanced when positioning a 1-tonne load (including hook) within its operating radius. The cause of the accident was subsidence under an outrigger.

During positioning of the load the rear outrigger (over the suspect area) slowly moved downwards about 500 mm causing the crane to tip. The operator was able to take evasive action by lowering the load, retracting the boom, and slewing the jib, thereby avoiding personnel and cushioning the impact. There was no injury and crane damage was minimal.

The crane which overturned during the lifting operation.

The site was examined after the accident and it was found that the rock formation was a 1200 mm wide x 200 mm thick cantilevered shelf over soft ground. The rock had fractured and rotated 60° under load causing the outrigger to slip off the packers and allowing the weight to be transferred to the underside of the outrigger.

This accident highlights the care required in carrying out the sometimes difficult task of assessing the ground bearing capacity and correct blocking (packing) of the outrigger pads. The following points need to be considered:

- It may sometimes be necessary to consult a person with expertise in soil types, such as a civil engineer, to determine if the required

support is available or if some ground works are needed to provide an adequate base. Repositioning may be a viable alternative to using a marginal area.

- Extensive ground probing from different angles will be necessary and the use of a penetrometer may be justified.
- AS 2550.1-1993 *Cranes – Safe use – General requirements* offers some information on safe

bearing pressures of different soil types for crane outriggers.

- The Power Crane Association *Crane Safety Manual* illustrates the blocking of outrigger pads.
- An accurate level indicating system, possibly with an adjustable preset tilt alarm, can provide warning of imminent collapse of outrigger support.
