# ACCIDENT ALERT

## Fall during log-loading kills waterside worker

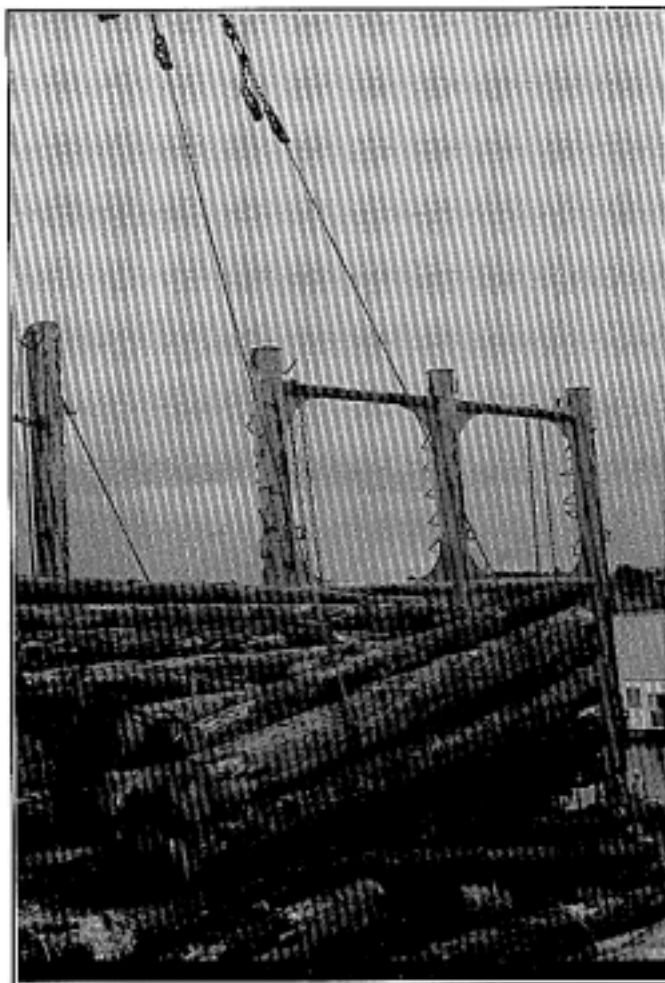
Log-loading operations underway spot, rather than walk around the crane tower.

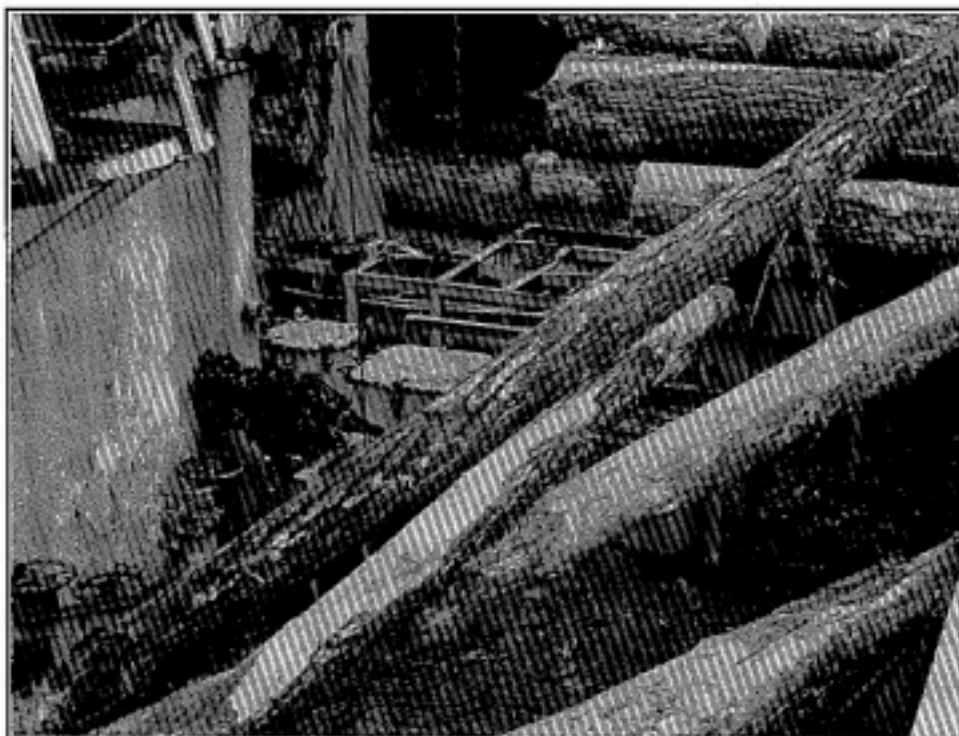
Ship's gear on to which the cargo worker fell
