Safety Lines

ENGINEERING SAFETY NEWSLETTER, OCCUPATIONAL SAFETY AND HEALTH SERVICE

No. 58, June 2003

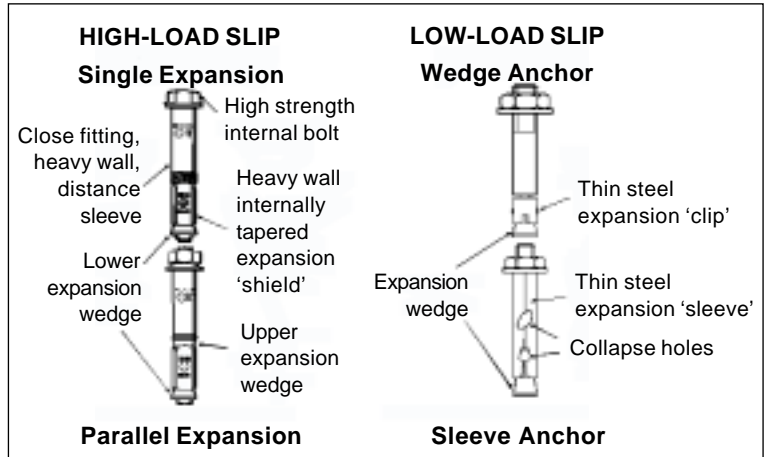
Fig 1: Load Controlled Anchors

Two examples of the acceptable load controlled anchors are shown in figure 1 of the bulletin. Experience gained since publication of the bulletin indicates that use of the high-load slip anchor (on the left) is preferable.
