ACCIDENT/INCIDENT ALERT

Operator's Hand Amputated in Hay Baler Accident

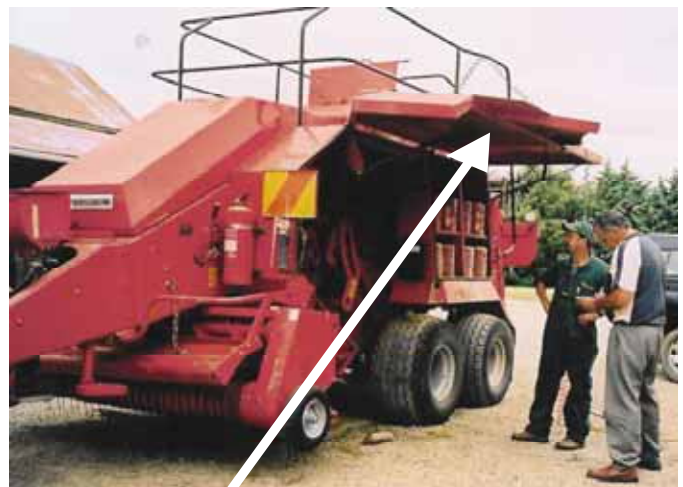
Guard that had been lifted to oil the chains

The tractor driver was servicing the hay baler in preparation for work. He had lifted the guard to provide access to the transmission chains and sprockets. The tractor engine was running and the PTO shaft on the tractor was engaged ready for operation; so all transmission on the hay baler was working.

Designers, manufacturers, and suppliers of plant must be aware of their obligations as set out under sections 66 and 67 of The Health And Safety in Employment Regulations 1995 and section 18(A) of the Health and Safety in Employment Act 1992. Specifically, they must ensure that their advice is in line with the manufacturer's instructions and any available safety modifications are provided. In this case, an automatic lubrication system would have avoided any exposure to the moving parts.

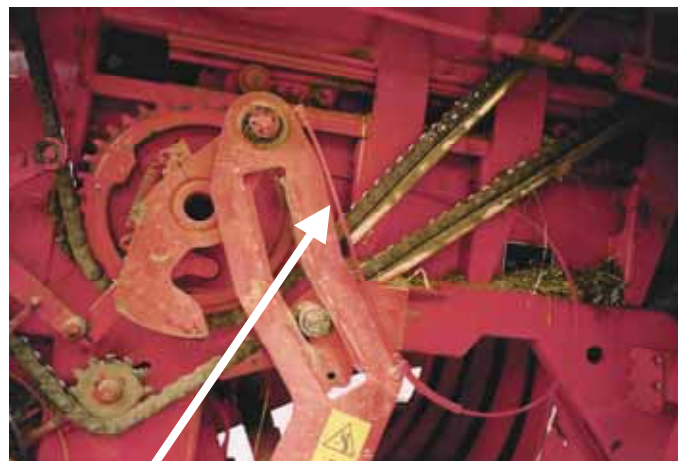
Area where the victim's hand was caught

The victim proceeded to oil the stuffer knotter drive chain, using a small plastic bottle that had a very short nipple. While oiling, he accidentally dropped the oiling bottle down behind the stuffer knotter drive chain, he inadvertently reached in to retrieve the bottle when the cog grabbed his thumb, then his wrist, and continued pulling him into the machine until it reached his biceps.
