## ACCIDENT/INCIDENT ALERT

No. 13, March 2006

# Unsafe A-frames used for transportation and storage of precast concrete panels

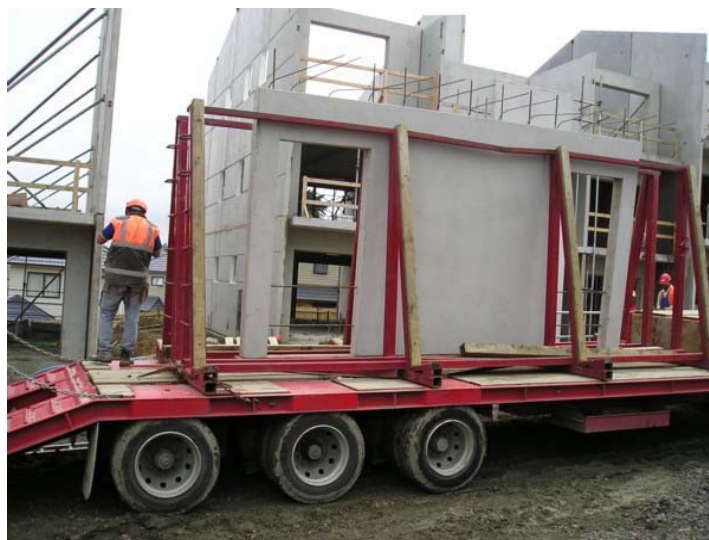
Photo 1: Panels arriving on site with frames showing signs of damage. This method of transportation is common practice in New Zealand.

- Each user should have a safe working method statement and supplier's information in accordance with section 18(A) of the Health and Safety in Employment Act 1992.
- Refer to the *Approved Code of Practice for the Safe Handling, Transportation and Erection of Precast Concrete* for further information.

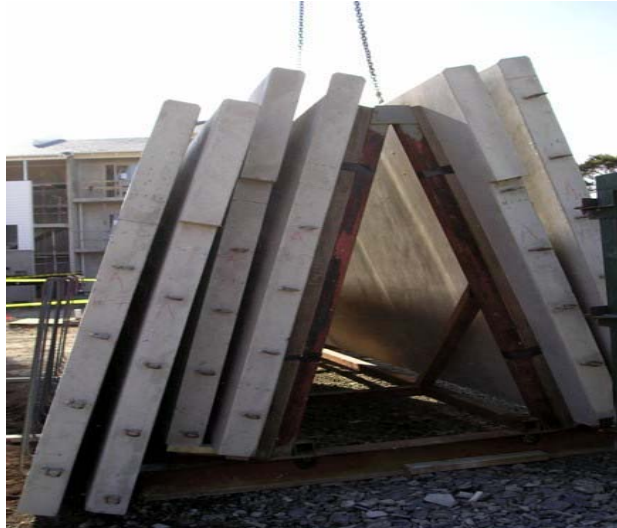
Photo 2: Concrete panels stacked, using current practice, on the frame, as the crane is about to lift it.

- Frames must be placed on clear, level ground to prevent them from rocking which may in turn result in failure of the frames or the panels sliding off.
- This risk is increased when the worker climbs the panel frame to attach the lifting equipment.

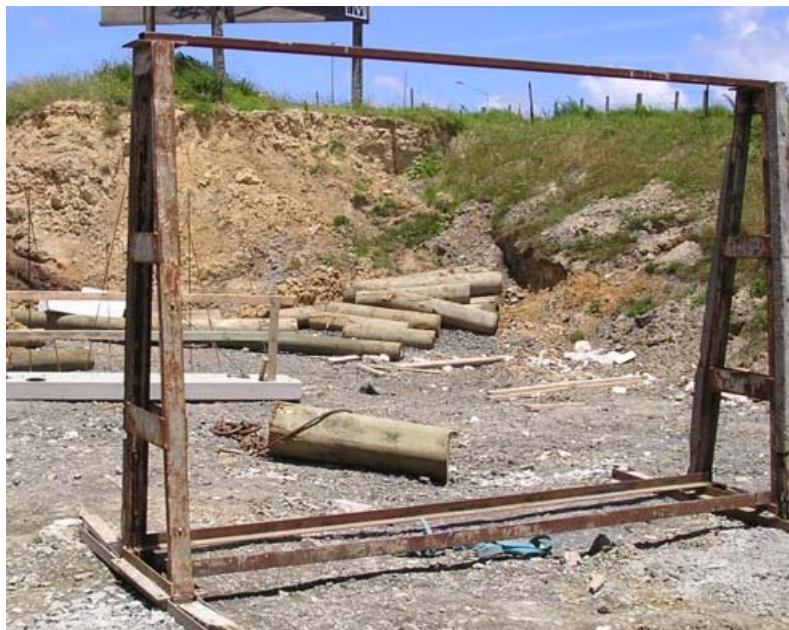
Photo 3: Empty A-frame
