## Safe Operation of Tip Trucks – Hazards During Tipping

### INCIDENT

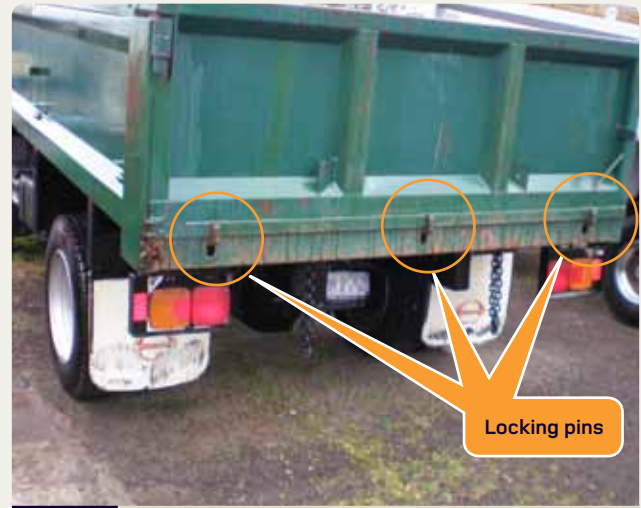
1

Tailgate section of tip truck with three locking pins securing the swinging tailgate to the tipping body.

- Regular inspection and repair (if necessary) of tailgate locking mechanisms.
- Vehicle repairs carried out by duly qualified persons.
- Driver awareness training, focussing on the dangers of working behind a raised tipping body.
- Raising awareness of the dangers of material getting hung-up during tipping. Loads may release suddenly and without warning.
- The installation of a secondary latching system located to the side of the trailer.
- Ensuring that the tailgate is unlocked before raising the tipping body.
