Stacking 1100kg Synthetic Material Super Sacks¹

INCIDENT

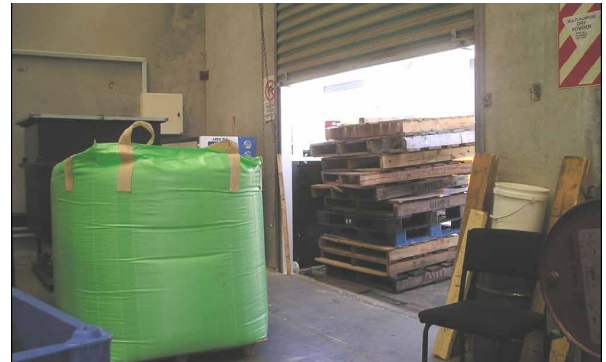
1

Picture 1: the size of the texPET sack can be viewed against the building's half-open garage door.

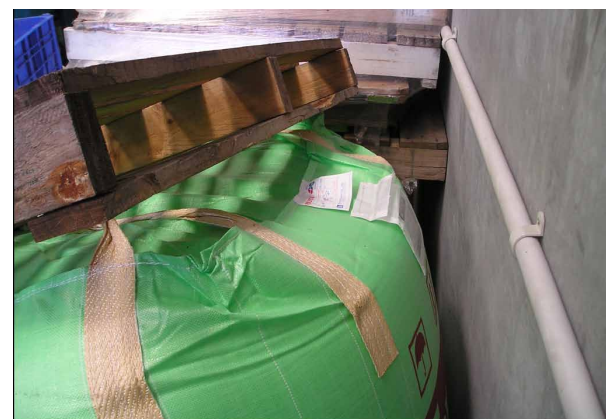
2

The investigation found that the highest super sack compressed, causing a change in its positioning and stability upon the middle super sack.

Picture 2: this photo displays the compression to a lower-stacked super sack from the bag that was previously stacked on top.

It is the Department's advice that synthetic type super sacks should be stored at ground level. Where there is a requirement for these sacks to be stacked vertically, precautions should be taken to prevent the sacks moving or settling by vibration.

The employer must take all practicable steps to identify this significant hazard and have in place an effective method to support and restrain the stacked super sacks.

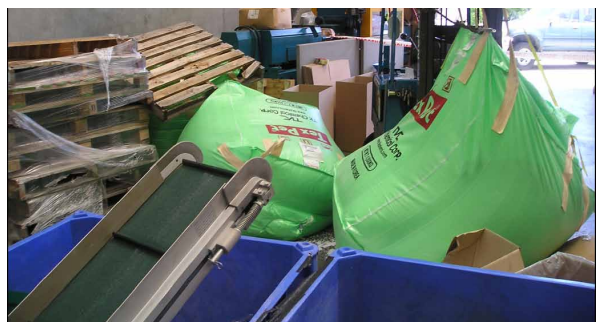
The operator had stacked three synthetic super sacks on top of each other against a supporting wall. No stabilisation was positioned between the top and middle sacks to support them.

Picture 3: this photo shows one super sack in the background stacked alongside the concrete wall (partially obscured by pallets and second super sack). Super sack 2 has fallen over, to land in front of super sack 1. Super sack 3 is the sack that crushed the worker. The bag's straps are hanging on the forklift's tines (the forklift was used to move the bag off the worker).
