Coolstore hydrocarbon refrigerant injures technician

INCIDENT

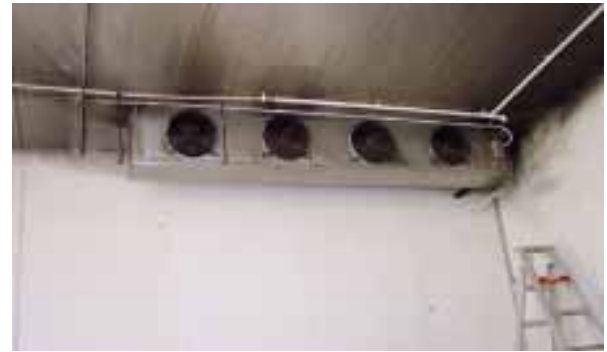
1

The technician was contracted to repair a valve on the refrigeration unit's evaporator inside the coolstore. The valve's markings stated that the refrigerant used in the system was R22.

The system was pumped down, isolating the bulk of the refrigerant to the main plant situated outside the building. The technician climbed approximately five metres up a ladder to access the valve and began replacing it, which involved welding around the valve area. The welding generated heat, which in turn caused a rapid expansion of the residual refrigerant inside the system. The refrigerant ignited, causing a rapidly expanding ball of fire to erupt from the system directly into the technician's face. He slid down the ladder to avoid further injury as the fireball rose to the coolstore's ceiling.

Picture 1: this photo shows the location of the evaporator unit inside the coolstore. The ladder off to the right indicates where the technician was working when the fireball erupted. Repairs were undertaken on the unit and nearby pipework after the fire, but fire damage to the coolstore's ceiling is still evident.

The Department of Labour recommends that employers, owners, persons in control of cool stores should *immediately* determine the substance their refrigeration unit/s are charged with. Where the system has been charged with a hydrocarbon refrigerant, they should determine if the system is suitable for that substance, having regard to the practical limit requirements as per AS/NZS 1677.2:1998¹.

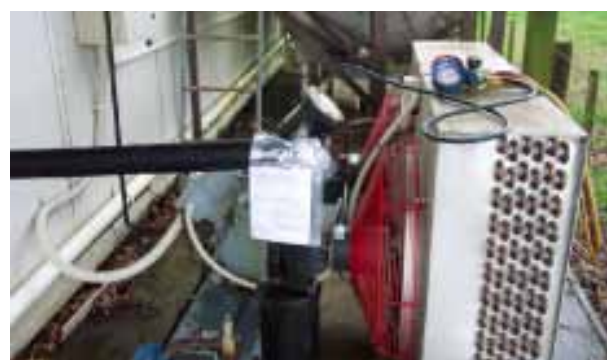
2

- The owner of the coolstore was not aware that a highly flammable/explosive refrigerant was being used in the refrigeration system.
- There was no signage to identify the refrigerant or hazard type, i.e. "Flammable".
- The system was not designed to be charged with a hydrocarbon refrigerant.
- No records were available to determine what the system had been charged with when commissioned. No subsequent records were available to suggest that the system had been retrofitted to operate using a hydrocarbon refrigerant.
- The owner of the plant and the technician believed that the system was safe and that it complied with all relevant legislative requirements.
- The refrigeration unit had been installed eight to ten years ago and had not required servicing subsequent to installation involving the refrigerant.

Picture 2: this picture shows the refrigeration plant located outside the coolstore.
