Scaffold truck with unsafe load in vehicle collision

INCIDENT

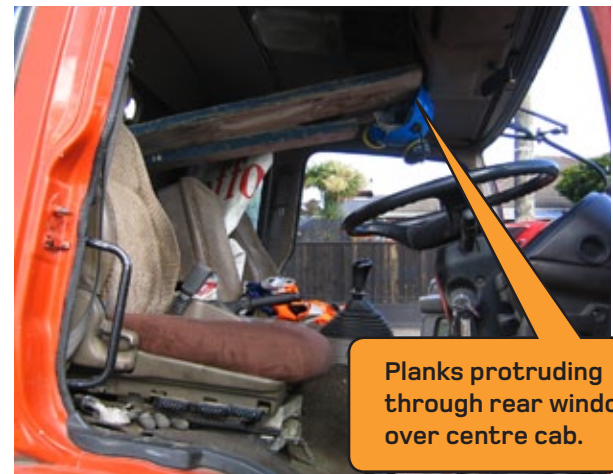
1

Planks protruding through rear window over centre cab.

Picture 1: this picture shows the scaffold truck's cab with the driver's door open. In between the driver's and passenger's head rests, two wooden scaffold planks have smashed through the cab's rear window and came to rest upon the roof of the cab.

The Department of Labour agrees with the New Zealand Police Commercial Vehicle Investigation Unit's (CVIU) findings – that if the load had been secured against a certified cab-guard, the chances of the load moving and creating further risk to the occupants of the truck and other motorists would have been greatly reduced.

The Department of Labour recommends that a certified cab-guard¹ as specified in the Land Transport New Zealand Truck Loading Code is installed on vehicles transporting any goods or materials that could shift during an accident.

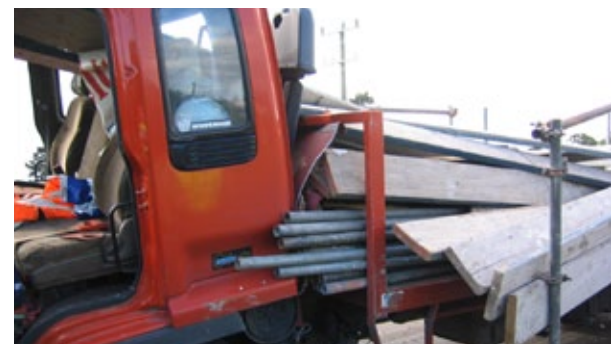
2

Picture 2: this picture shows the truck's cab from the passenger's door. On the truck deck, planks of wood and scaffold poles have come apart from the loading strops, pushing up against the back of the cab.

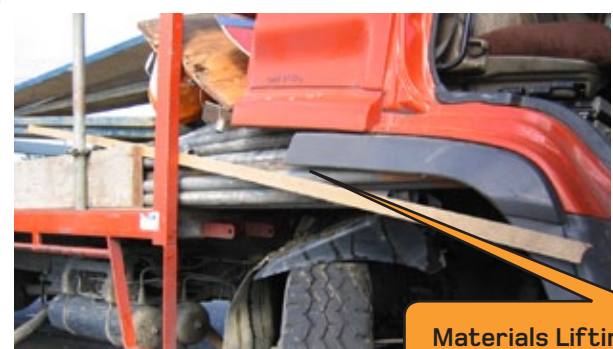
3

Materials Lifting Cab

Picture 3: a close-up of the truck's cab and storage deck shows that scaffold poles have slid underneath the truck's chassis, pushing the rear of the truck cab upwards.
