Membrane Skinner Accident

INCIDENT

A meat process worker was seriously injured while cleaning the blade and rollers of a membrane skinner.

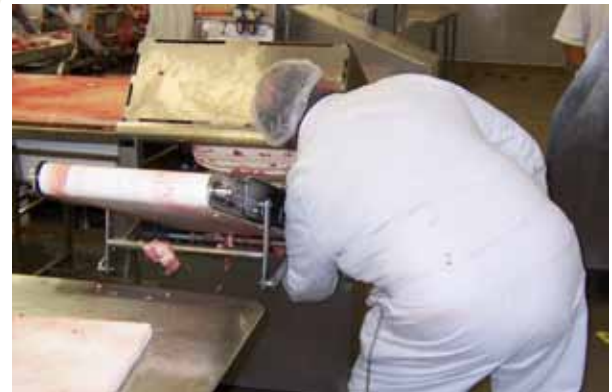
Workplace Health and Safety has established that although the Townsend 9000A membrane skinner is guarded at the feed-end, the toothed roller can be reached from the discharge end (Photo A & B). This hazard has been identified on other types of membrane skinner. Subsequent improvements to guarding beneath the discharge belt have been made on this machine (see Photo C). Improvements of this kind could be made on other membrane skinner models.

Photograph 1 shows the position from where the blade and rollers can be reached from under the discharge belt.

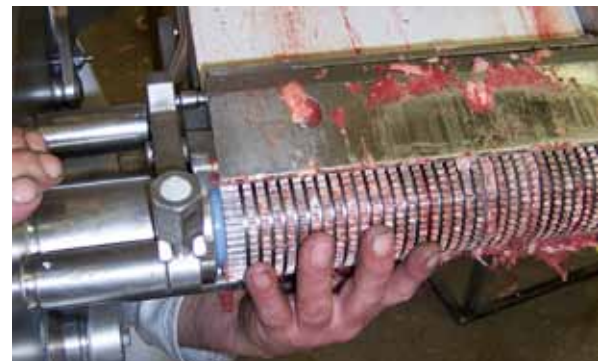
It appears that the process worker had inserted his left hand into this gap to clean fat and oil from the blade and rollers when the machine unexpectedly restarted, causing multiple finger amputations and severe lacerations to his hand.

Photograph 2 shows where the victim's hand contacted the roller; the intake belt would normally be adjacent to the roller, but is absent in this photograph.

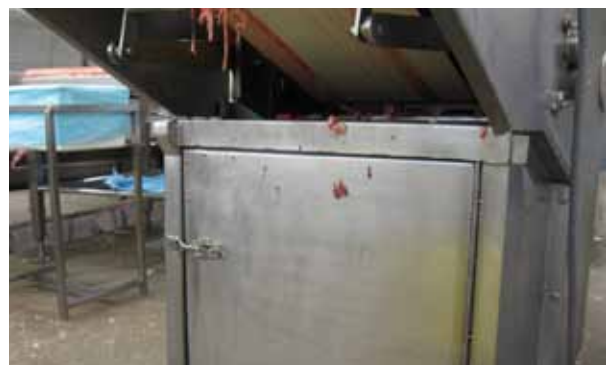
Photograph 3 shows the interlocked door which contains a space for waste, and prevents access under the discharge belt.

Employers that use membrane skidders should check their machines to ensure that operators cannot access the blade and rollers. Employers should also ensure that there is a process in place to isolate and lock-out machinery during cleaning and maintenance.
