# General Workplace Inspectorate

## ACCIDENT/INCIDENT ALERT

### Vehicle Wheelchair Hoist Accident

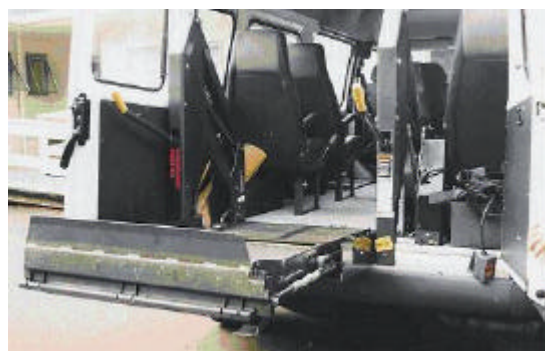
**Above:** Hoist in horizontal position ready to receive a wheelchair

When the hoist was in the horizontal position, at floor level there was a short platform to bridge the gap between the vehicle and hoist. At this level or when lowered approximately 750 mm to the ground it was possible to exit via the back of the van, because there was no barrier to prevent inadvertent egress either for wheelchairs or residents who were able to walk.

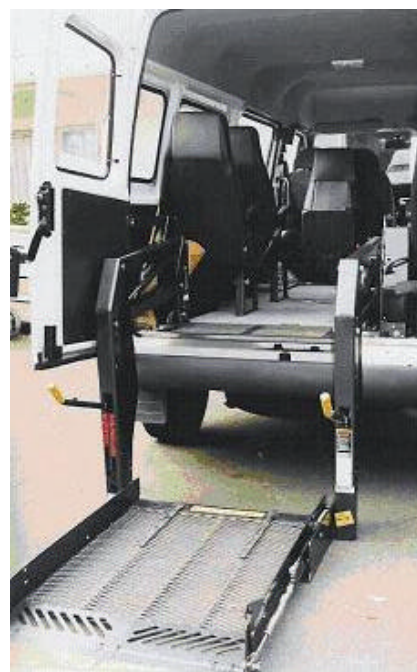
**Above:** Hoist in down position – no guard to prevent inadvertent egress.

1. There was no specific safe operating procedure for this operation.
2. On the day of the incident the routine had been changed. Instead of one person disembarking residents from the van and returning them to the rest home, a relief nurse was helping with the operation. There was poor communication between the recreation officer and the relief nurse in carrying out the task.
3. When the recreation officer had carried out this task on her own, regular practice had been to return the hoist to the up horizontal position before taking the resident inside the rest home. On this occasion, this was not done, and the recreation officer assumed that the hoist was in the horizontal position when in fact it was not.
4. While the hoist was in good condition, there was no physical barrier to prevent an exit from the van before the hoist was in place.

1. This task needs to be included in the Rest Home Hazard Identification System. Good procedures would indicate that two people should do this operation with specific tasks, not only for disembarking wheelchairs but to ensure the safety of residents left waiting in the van for their turn to disembark, either by wheelchair onto the hoist or via the door for more able residents.
2. A better option, in addition to the procedure above, would be an isolating barrier preventing residents exiting from the rear of the van when the hoist is in the down position.
3. The barrier needs to be sufficiently sturdy to prevent inadvertent wheelchair egress.

4. Care would need to be taken to ensure that the integral design and safe operation of the hoist is not compromised, or egress from the van is not restricted.
5. Preferably the physical barrier should be linked in some form to the operation of the platform of the hoist. This could be either hydraulically or electrically, to ensure exit cannot be made without the hoist in the up horizontal position.
6. The photos below show one solution (there may be others on the market), which is available for attachment to certain hoists. This is the Watchdog Lift Barrier System, and provides an isolating barrier until the hoist is returned to the up horizontal position.
