ACCIDENT/INCIDENT ALERT

15 October 2004

Primary Hopper – Fall Fatality

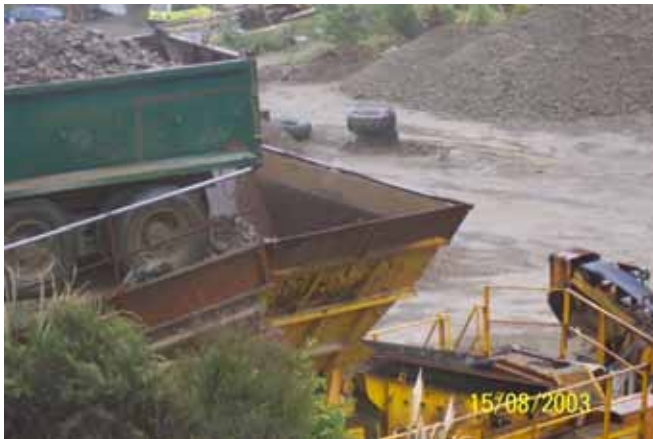
A quarry worker was fatally injured when he fell 2.2 metres into an almost empty primary feed hopper of a crushing plant.

The worker had reversed his truck up to the primary hopper in order to discharge a load of quarried material.

He then walked to the rear of his truck, before falling into the hopper.

1. Nothing prevented workers falling into the hopper while standing close to it, using a rod to free materials that were stuck or jammed on the sides of the hopper. This condition was common, particularly when the quarried material was wet, and

2. While guardrails existed at the sides of the vehicle approach to the hopper, a dedicated observation area did not exist, should such an area be required for viewing into the primary hopper.

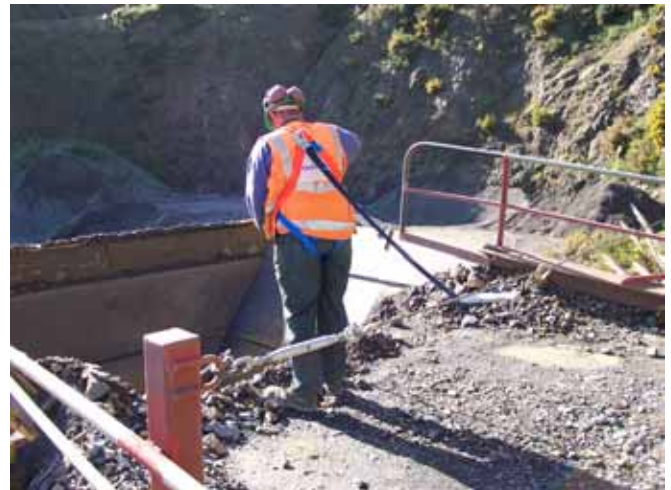
1. A securely anchored static line to which a safety harness is attached, to minimise the harm that could occur should a person fall. For ease of accessibility, the static line and harness are kept in a securely locked weatherproof cabinet a few metres from the primary hopper.

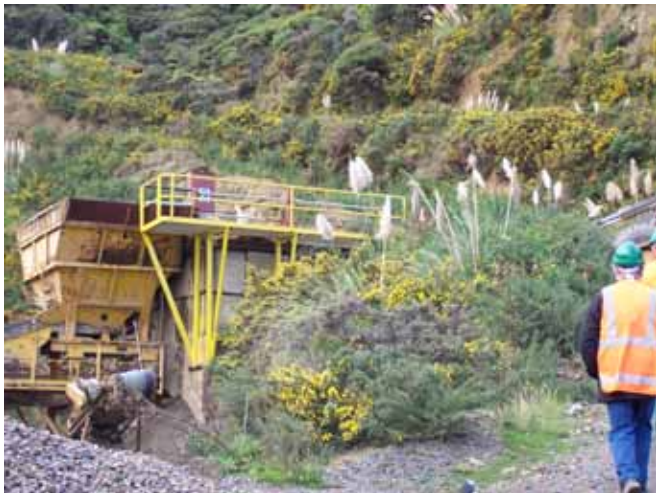
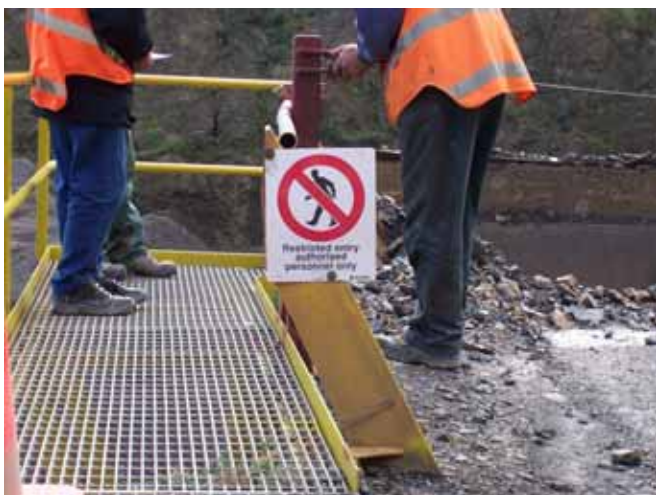
2. An observation walkway with top and mid guardrail protection and an end return platform was erected to the driver's side of the approach to the primary hopper.
