## ACCIDENT/INCIDENT ALERT

No. 4, September 2005

# Forklift Operator Fatality

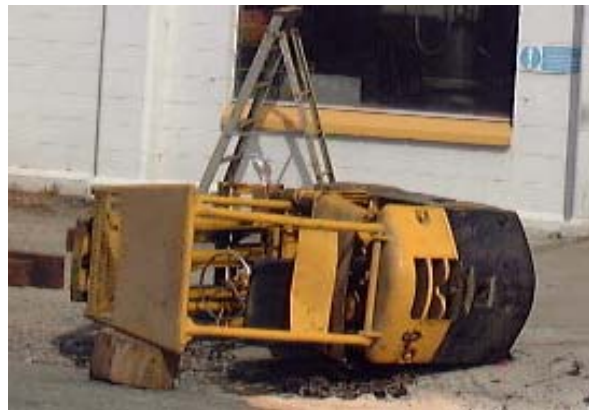
A forklift operator received fatal injuries when the forklift he was operating overturned on a ramp he was descending.

A passer-by discovered the 1-tonne-capacity forklift overturned on a ramp, which exited from the building onto a roadway. The operator was found trapped between the frame of the forklift and the ground.

- The forklift operator was not trained to operate a forklift but had operated them before under supervision.
- The forklift was an obsolete model in poor mechanical condition i.e. the tyres were of unequal pressure, the steering linkages were severely worn, and the brakes were ineffective.
- The forklift had not been left in an inoperable condition.
- The forklift appears to have been turning while descending the ramp.
- The forklift was used without the employer's knowledge.
- At the time of the accident the forklift was not being used in its intended semi-static situation inside the workshop to lift items in and out of a hydraulic press.

Forklift as it came to rest after the accident

- Maintain forklifts to NZS B56 and NZS 2359 as a minimum.
- Only trained and authorised operators are legally permitted to use a forklift. Employers should implement strict guidelines for forklift usage in accordance with the *Approved Code of Practice for Training Operators and Instructors of Powered Industrial Lift Trucks (Forklifts)*. All operators are required to be trained to the minimum standard presented in the code.
- This accident highlights the hazard of staff working alone and the importance of training and supervision.
- Check the environment in which a forklift is to be used for hazards such as ground surface conditions, potholes and slopes etc. before beginning.

**Never turn a forklift on a slope.**
